POSSIBLE BLOCKAGE OF O₂ QUICKSTICK SENSOR END CAP

SPECIAL NOTICE TO CUSTOMERS & DEALERS Possible Blockage of Nuvair O₂ Quickstick Sensor End Cap Sampling Orifice

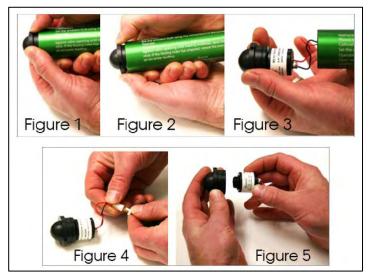
Figure 2. Removal and replacement steps.

- (1) Place mouth over the hole of the sampling orfice and suck gently. If the orifice is clear, air will enter from the two (2) exhaust ports located on the sides of the sensor end cap (see Figure 1). If the orifice was blocked, a pinhead-size piece of black plastic may enter your mouth. Be careful not to inhale the plastic piece.
- (2) If the obstruction cannot be cleared, remove the sensor end cap from the oxygen sensor and visually inspect the sampling orifice (see Figure 2). If the orifice is blocked, use a straighted paperclip to clear the blockage from the orifice. Once the orifice is confirmed to be clear, replace sensor end cap.

For additional assistance with removal of the sensor end cap, watch our one-minute YouTube video, "O2 Quickstick Sensor Replacement," at https://youtu.be/4GlLLmdNywk.

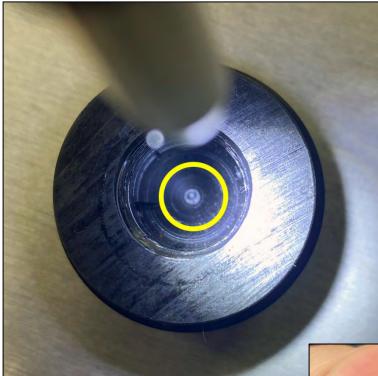
Figure 3. Aided with a flashlight, obstruction as viewed from inside sensor end cap.

These images show the sensor end cap orifice obstruction. The orifice is highlighted with a yellow circle. Both images are views of the sensor end cap where the oxygen analyzer is screwed into place.

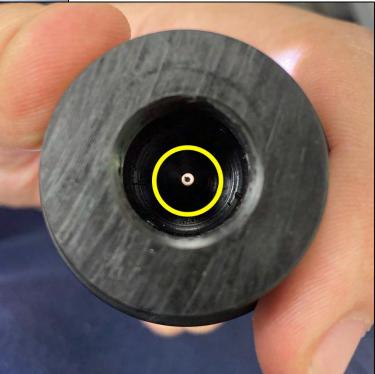
As shown in Figure 4, the plastic obstruction is paper-thin and can be easily cleared with a straightened paperclip or by blowing into the orifice when the sensor end cap is unscrewed from the oxygen analyzer.

Figure 4. With flashlight pointed at tip of sampling orifice, obstruction as viewed from inside sensor end cap.
